SEISMIC SAFETY SPECIAL STUDY FOR MISSION BAY

September 1986

CITY AND COUNTY OF SAN FRANCISCO

EQE Job Number: 86072.01

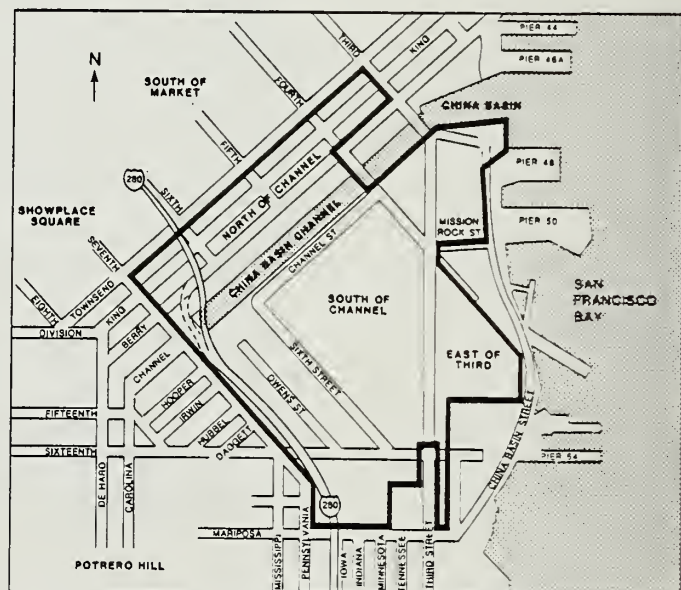
Figure 1-2: Site Plan of the Mission Bay Project

The Mission Bay Project area is a relatively undeveloped area at this time. The location of the project is shown in Figure 1-1. The perimeter of the project can be described as Townsend Street, China Basin Street, Mariposa Street, and Seventh Street (see Figure 1-2).

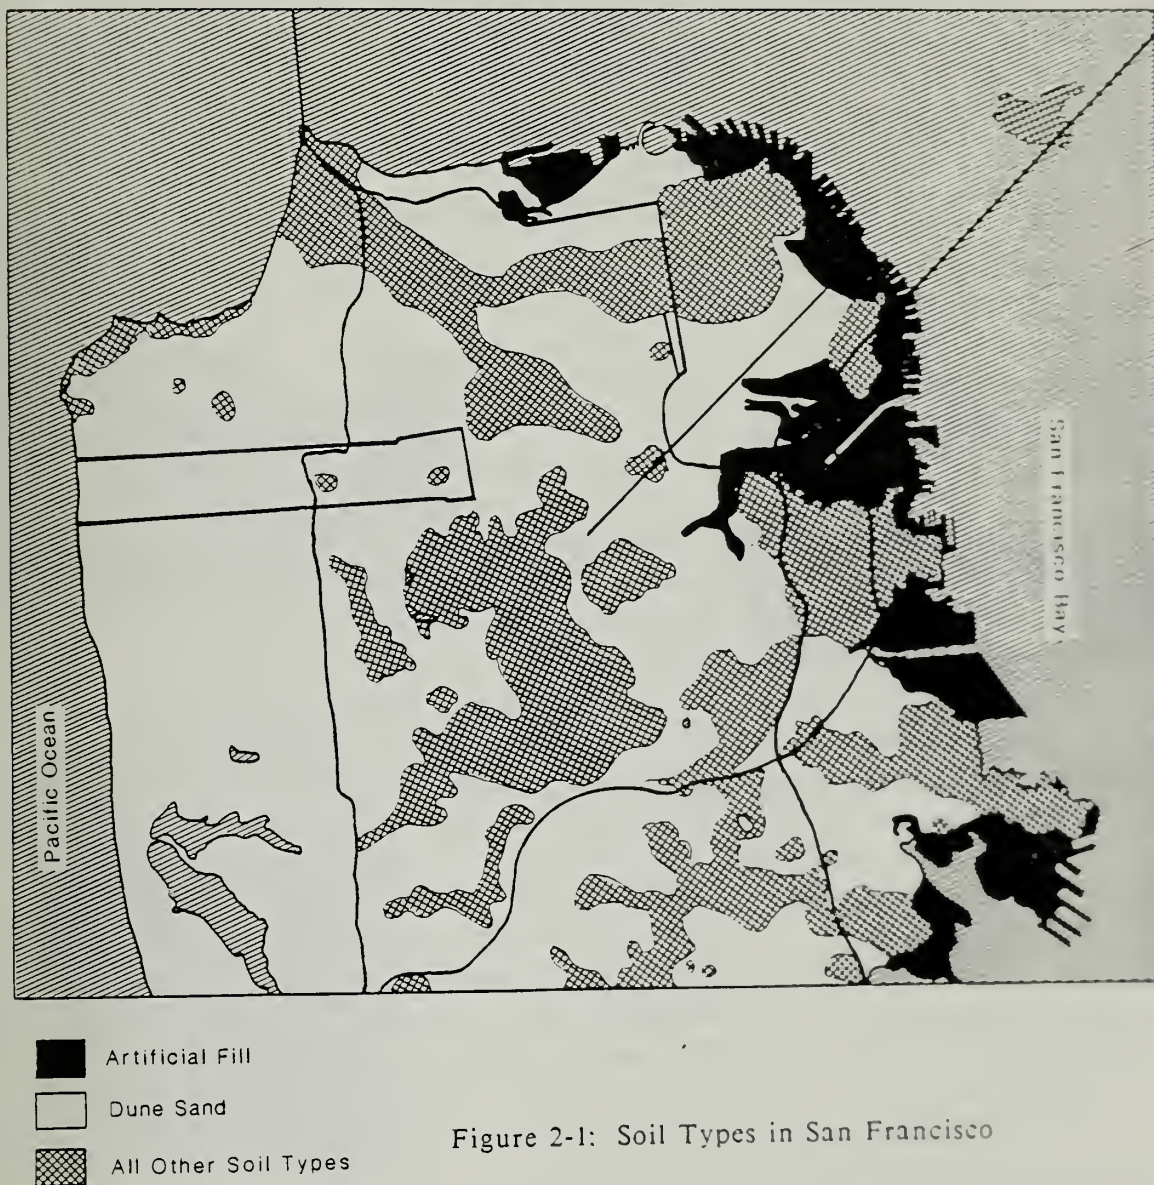
The seismic hazards at Mission Bay are comparable to those at many other large areas of San Francisco. Figure 2-1 is a general illustration of soil types throughout San Francisco. The buildings at Mission Bay, when completed, will represent the state-of-the-art in earthquake engineering. If the above recommendations are followed, increased safety at a very moderate cost will ensure that the buildings will represent low to moderate seismic risks. That will be in contrast to many other parts of San Francisco where risky older buildings predominate. Overall, the risks for injury from an earthquake to inhabitants of Mission Bay will be lower than most of San Francisco.

The hazards and the resulting risks to the Mission Bay site are typical for several large areas of San Francisco. For example, similar hazards exist for most of the northeastern and eastern shoreline areas of San Francisco, including the Marina, Fisherman's Wharf, the Financial District bounded by Telegraph Hill, the Bay Bridge approaches, and The Embarcadero and Montgomery Streets, much of the area south of Mission Street extending to Hunters Point, and San Francisco International Airport (see Figure 2-1).

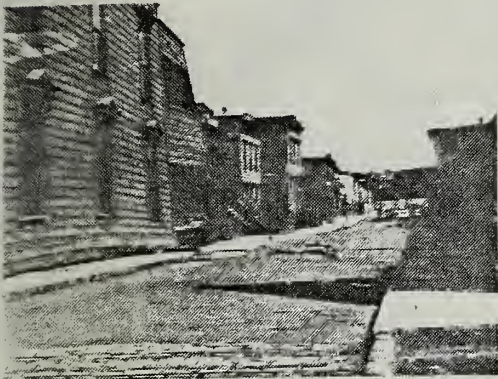
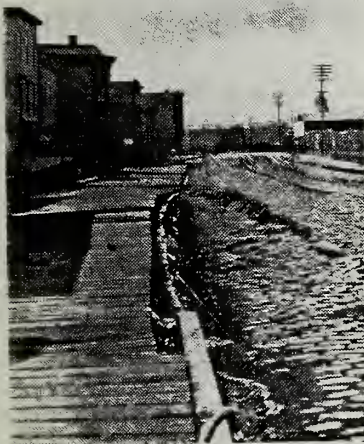
- **Performance of the elevated highways** which run along portions of the perimeter of the site. It is likely that the elevated highways will suffer considerable damage. Given the redundancy of the existing interchange structure and the performance of similar structures during past earthquakes, we consider it a very remote possibility that general collapse of the interchange would occur blocking all access. The elevated highways themselves may not be usable, but this will not block access to and egress from the Mission Bay site. Surface streets may suffer damage, but should be passable by emergency vehicles or light trucks (see adjoining illustrations of 1906 street damage).

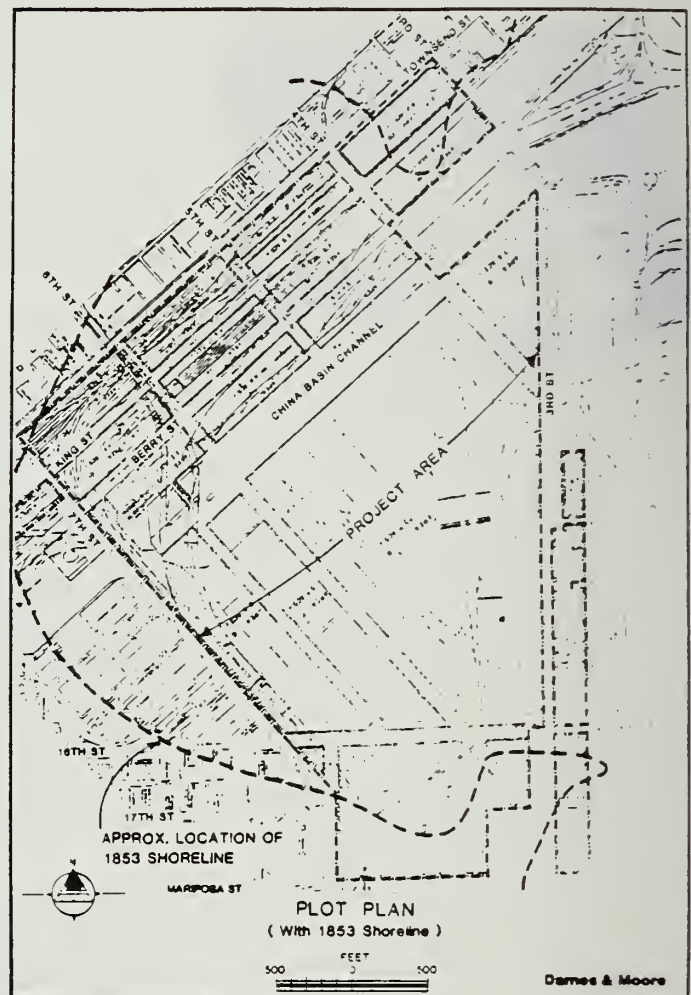
Plate 1

Figure 3-1: Plan View of Mission Bay Site Showing Approximate Location of 1853 Shoreline (Reference 13)

A plan view of the Mission Bay site is shown in Figure 3-1. It is triangular shaped and is approximately bounded on the west side by Seventh Street, on the north side by Townsend Street, and to the east by China Basin Street. The northern third of the site is separated from the remainder of the site by China Basin Channel. North-south access between these two areas is provided by drawbridges at Third and Fourth Streets.

As shown by Figure 3-1, most of the Mission Bay site is filled land that is exterior to the 1853 shoreline. Fill materials are random in nature and are underlain by soft bay mud up to 120 feet in thickness. It is thought that most fill material was placed between 1865 and 1906. Some of the site may have been used as a refuse dump and as a repository for debris from the 1906 earthquake.

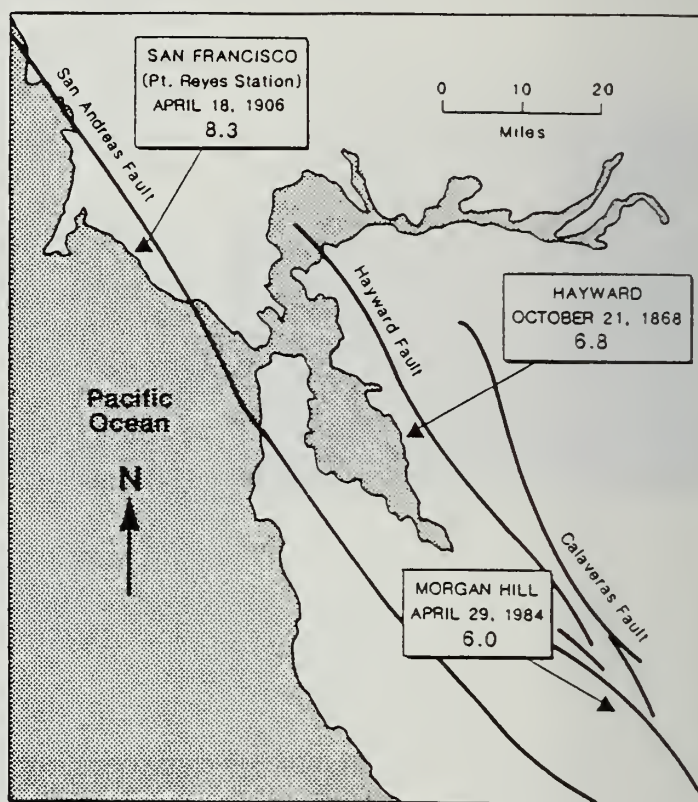
Figure 3-2: Mission Bay Site Relative to Major San Francisco Bay Area Faults.

There are several active faults in the Bay Area capable of causing strong ground shaking at Mission Bay. The locations of these faults relative to the project are shown in Figure 3-2.

The Mission Bay site is located in one of the highest earthquake risk areas in California. Several large, well-known, active faults are in the general vicinity including the San Andreas, Hayward, and Calaveras faults. These faults have caused several destructive earthquakes in the past and are potential sources of future destructive shocks. The location of the site relative to major San Francisco Bay Area faults is presented in Figure 3-2.

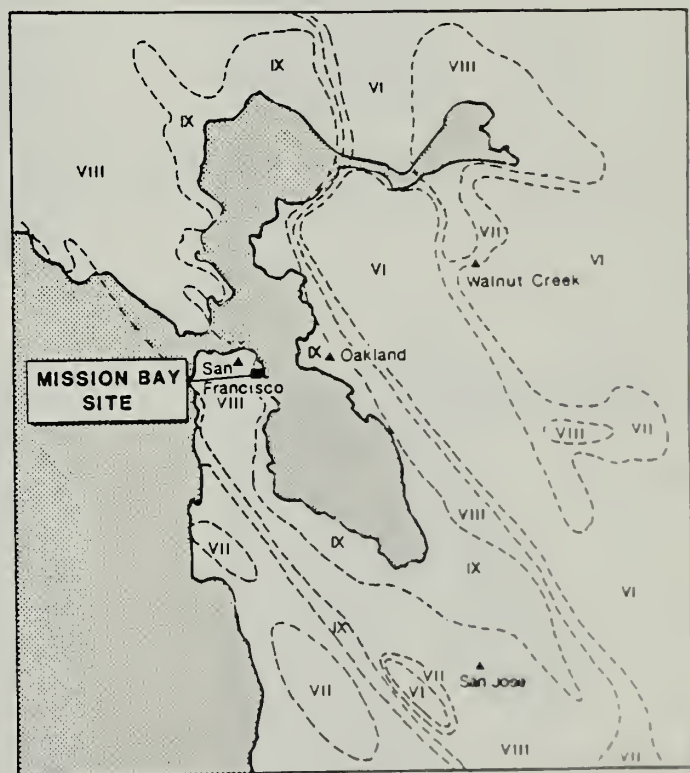
Figure 3-3: Modified Mercalli Intensity Distribution for an MCE ($M=8.3$) on the San Andreas Fault.

The three faults likely to cause the strongest ground motion at the Mission Bay site are the San Andreas, Hayward, and Calaveras fault zones. Table 3-2 summarizes expected ground shaking intensities in the Mission Bay area due to both an MPE and an MCE occurring along these faults. Results indicate the controlling MCE is along the San Andreas fault. The maximum expected MMI at the site is IX. The MCE event on the Hayward fault would produce nearly the same intensity of ground motion.

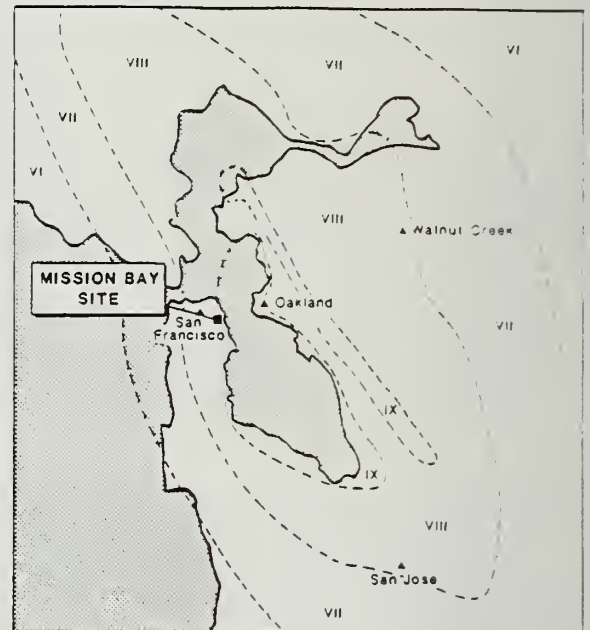
Figure 3-4: Modified Mercalli Intensity Distribution for an MCE (M=7.5) on the Hayward Fault.

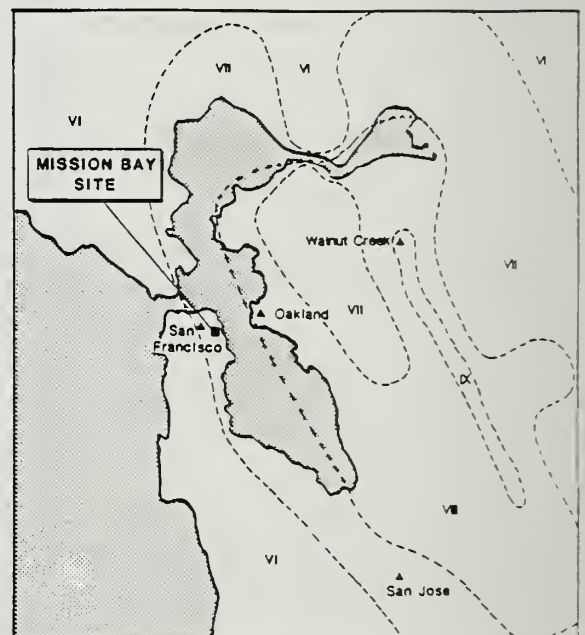
Figure 3-5: Modified Mercalli Intensity Distribution for an MCE (M=7.0) on the Calaveras Fault.

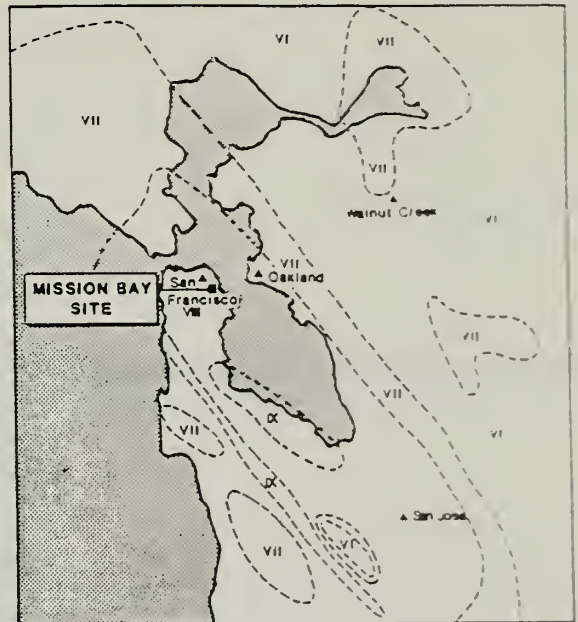
Figure 3-6: Modified Mercalli Intensity Distribution for an MPE (M=7.0) on the San Andreas Fault.

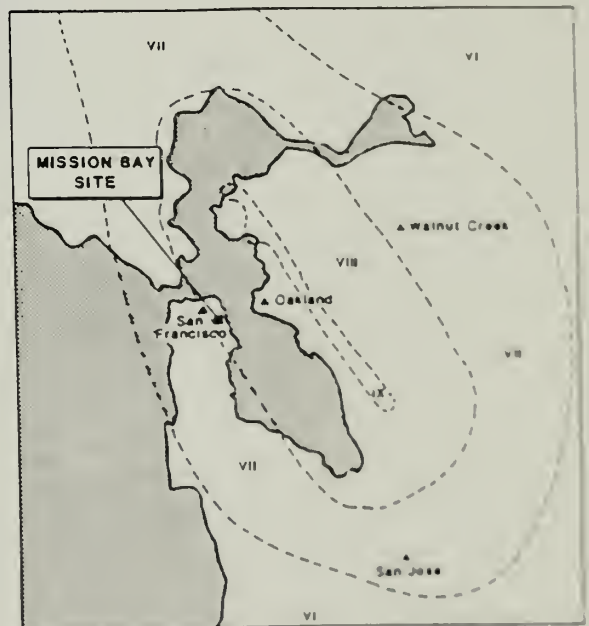
Figure 3-7: Modified Mercalli Intensity Distribution for an MPE (M=6.8) on the Hayward Fault.

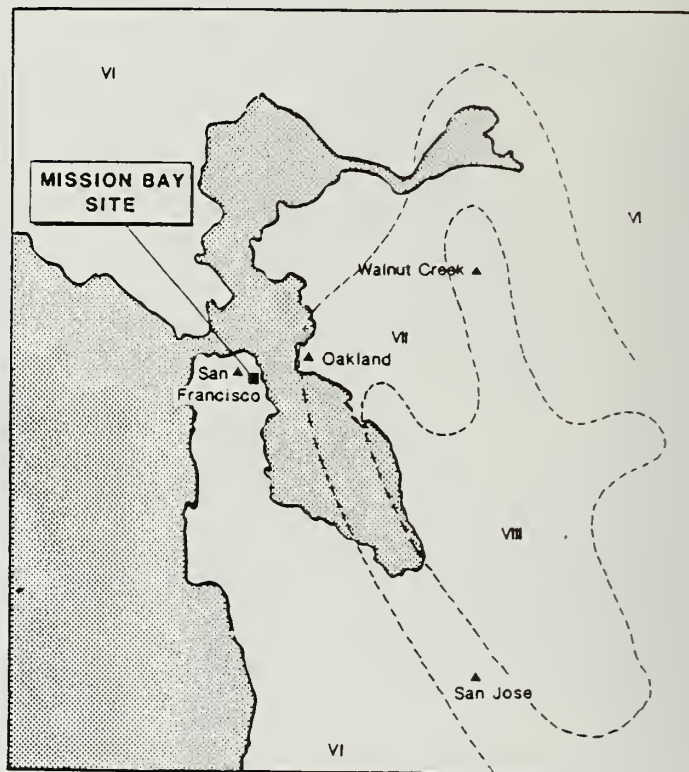
Figure 3-8: Modified Mercalli Intensity Distribution for an MPE (M=6.4) on the Calaveras Fault.

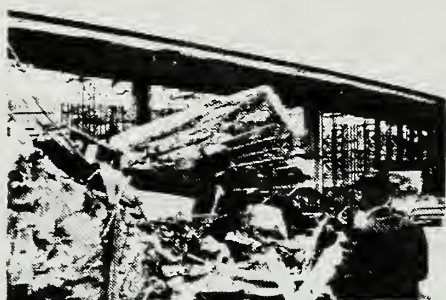
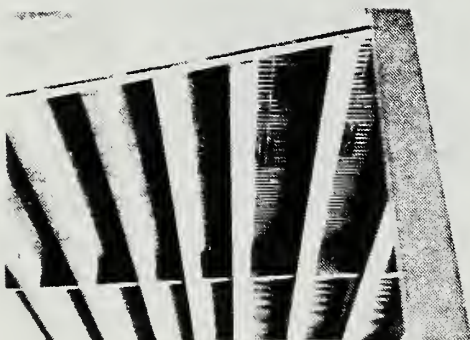
Structural drawings of the original freeway segment indicate that it is constructed from pre-cast, prestressed beams that span between the support frames. Supporting frames have either two or three columns. The foundation consists of H-piles with pile caps with piles normally driven to bedrock. There are no batter piles to carry lateral earthquake loads.

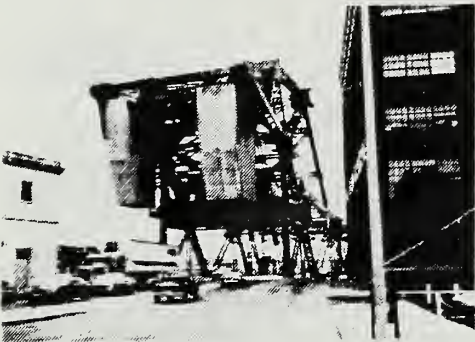
Third and Fourth Street Drawbridges. Draw (or bascule) bridges are located across the China Basin Channel at Third and Fourth Streets. Both are of steel truss construction and depend on heavy reinforced concrete counterweights to provide the weight required to operate their cantilever lifting mechanism.

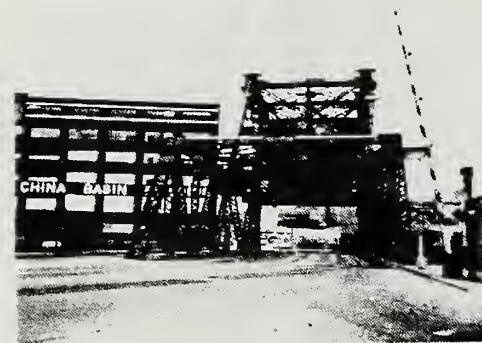
The Third Street bridge, called the Francis "Lefty" O'Doul Bridge, was designed in 1932. The bridge is supported on three concrete piers on wood piles. Both vertical and batter piles were used. The bridge has a span of 142 feet and a width of about 80 feet. The approach structure on the south side of the bridge is constructed of a reinforced concrete slab and girders and is supported on vertical concrete piles.

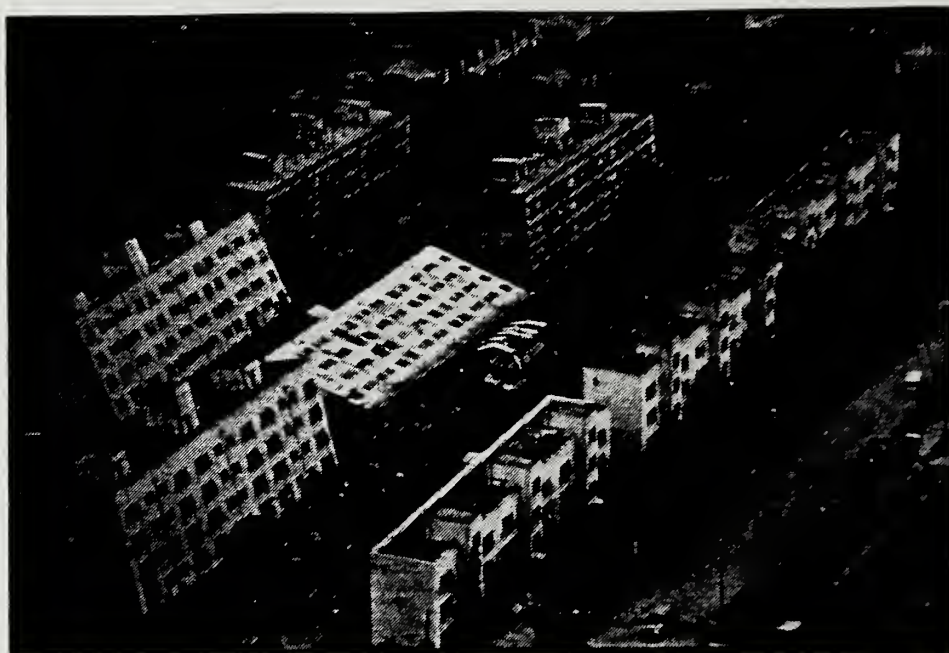
Figure A-1: Loss of Soil Bearing Capacity Beneath Apartment Buildings Due to Soil Liquefaction

Liquefaction. Liquefaction is a sudden loss of bearing strength that can occur when saturated, cohesionless soils are strongly and repetitively vibrated. When liquefaction occurs, loose saturated granular soils densify and increasing pore-water pressure forces water to flow upward to the ground surface where it emerges in the form of fountains and sand boils. The upward flowing water produces a temporary "quick-sand" that can result in a temporary loss of foundation support. The resulting damage can be very severe as illustrated by Figure A-1.
